Docket No. 217 – Development and Management Plan Inspection

Northeast Utilities Service Company Certificate of Environmental Compatibility and Public Need for the construction of a 345-kV electric transmission line and reconstruction of an existing 115-kV electric transmission line between Connecticut Light and Power Company's Plumtree Substation in Bethel, through the towns of Redding, Weston, and Wilton, and to the Norwalk Substation in Norwalk, Connecticut.

Date: February 16, 2006

Location: Overhead Line (Composite 345kV and 115kV Gallows Hill to Archers Lane) and (345kV H-Frame Hoyts Hill to Gallows Hill)

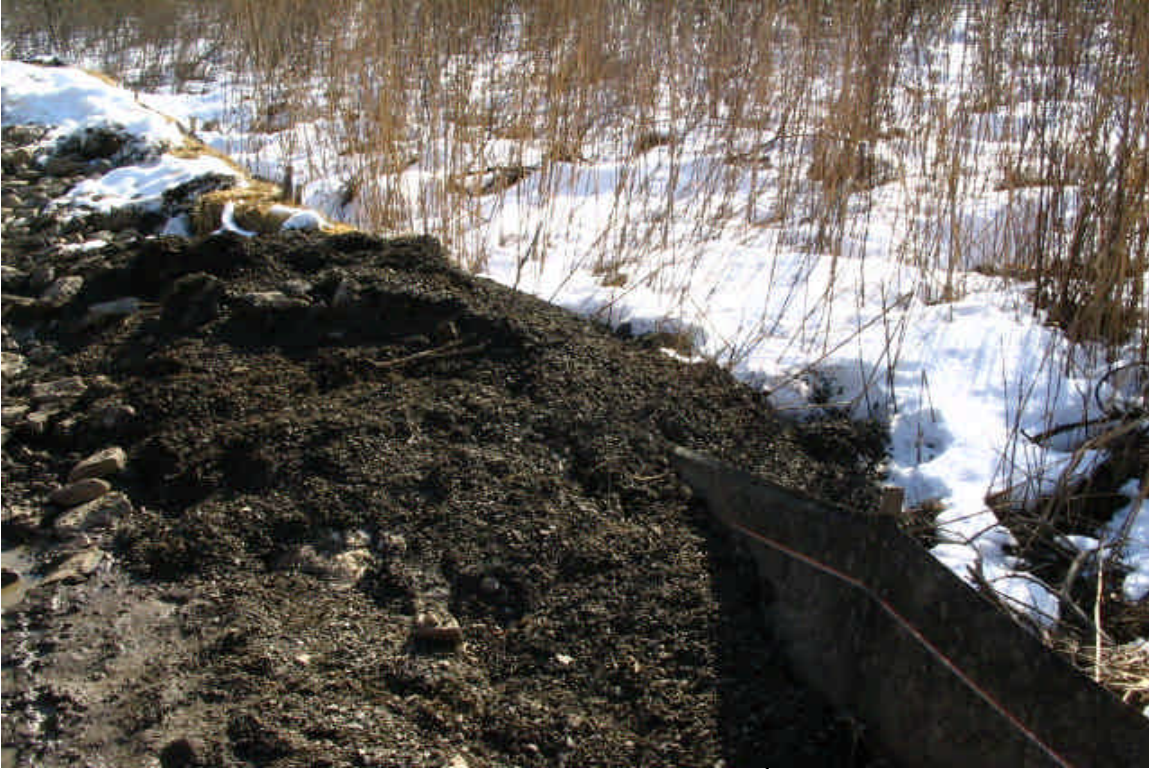
(Composite Section): Photo on the left shows a view of the 2nd crossing along the road from Archers Lane. Snow removal/plowing caused several locations where sediment was pushed over the controls. This needs to be pulled back from the wetlands. 2/16/06

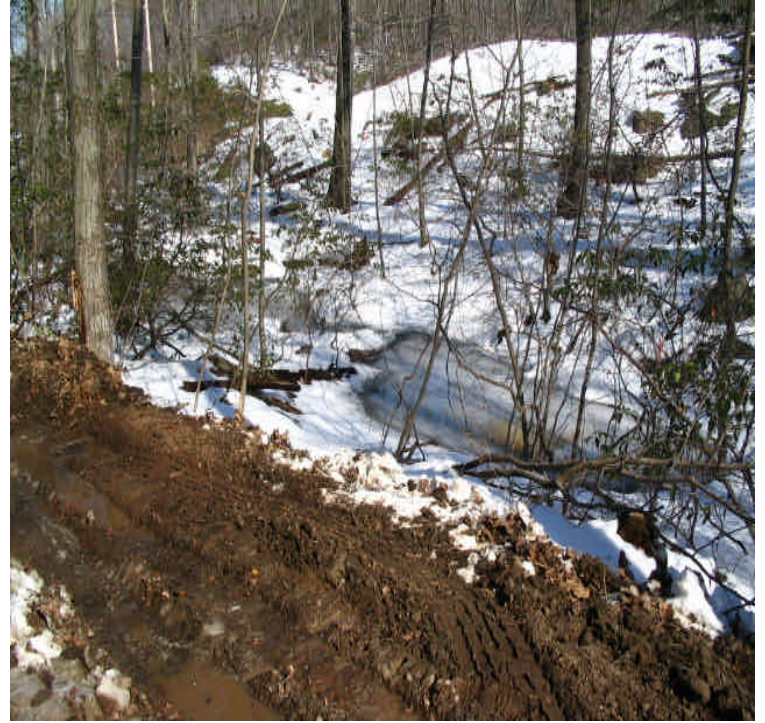
345kV (H-Frame Section): Photo on the left shows work taking down existing lines at the location of proposed pole #21. Photo on the right shows where muddy conditions on the access road have resulted in sediment run-off to the wetland pockets. Erosion controls should be installed in this section. 2/16/06

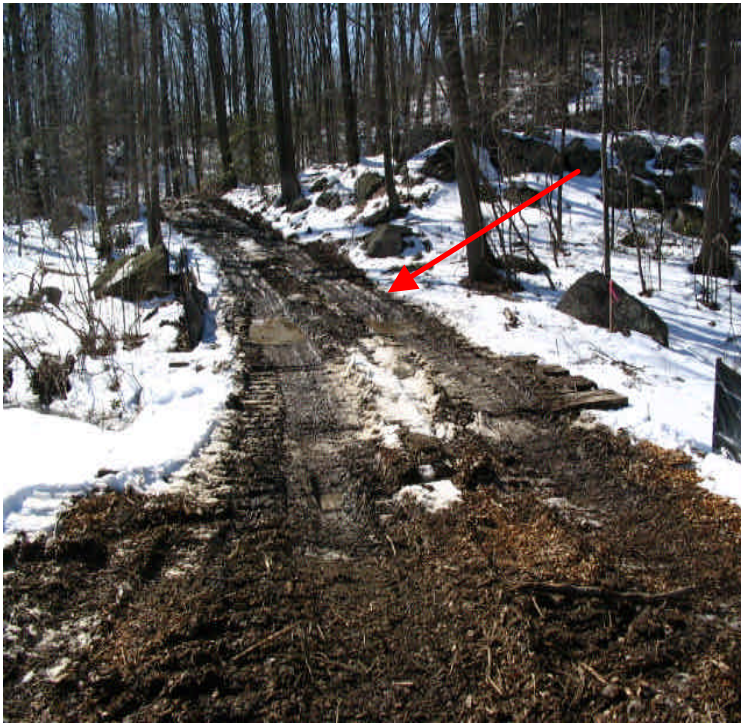
Photo on the left shows where a second mat should be installed near the stream crossing at pole #19 to increase stability. Photo on the right shows the erosion control installed along the access road in the same area. 2/16/06

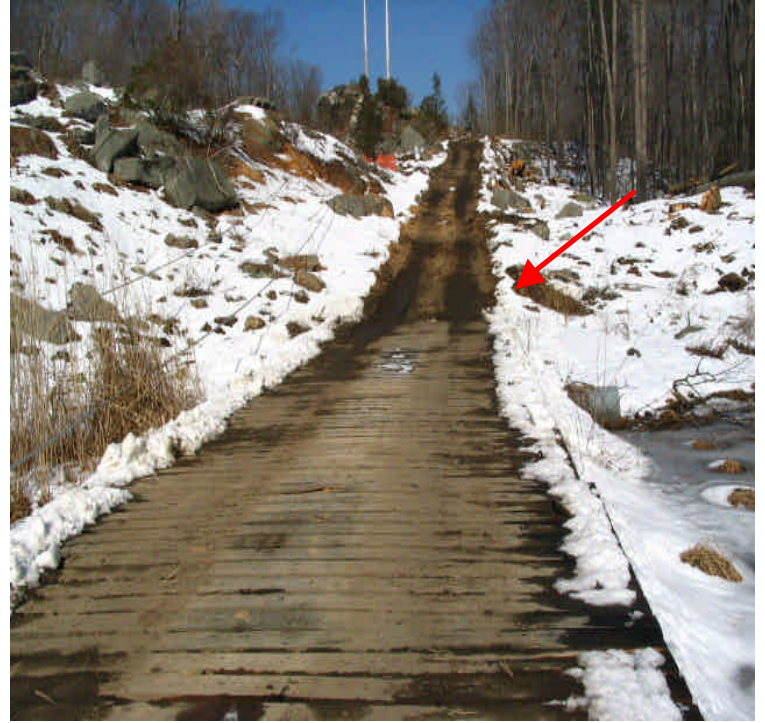
Photo on the left shows excavation occurring at a pole location along the Bethel Reservoir section. Photo on the right shows the wetland crossing between poles #17 and 18. Chips placed in the access road here have helped the tracking situation but silt fence should be installed at the approach. 2/16/06

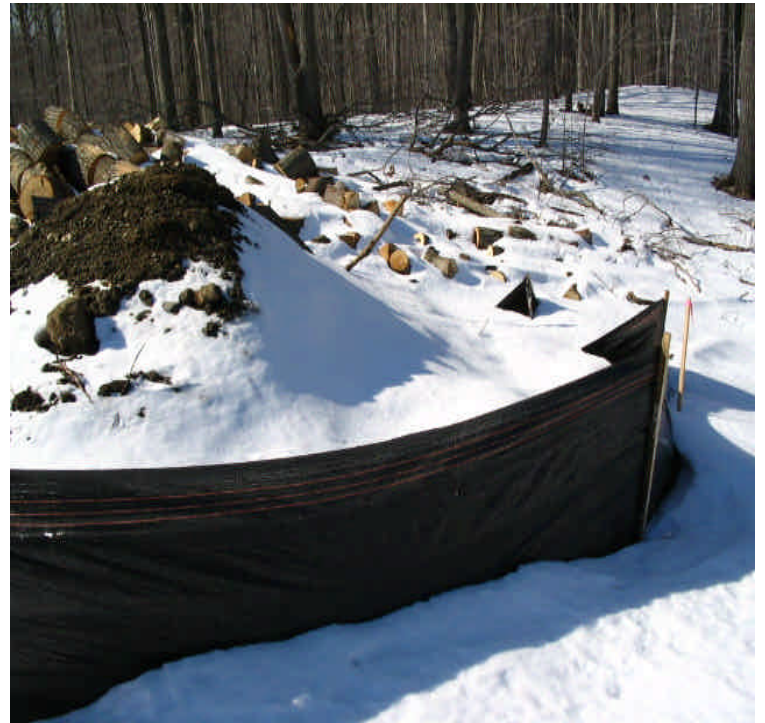
Photo on the left shows a cleared area and lines being taken down in the Bethel Reservoir section. Photo on the right shows a stockpile with silt fence in place. The fence should be checked if repairs are needed following the snow melt. 2/16/06

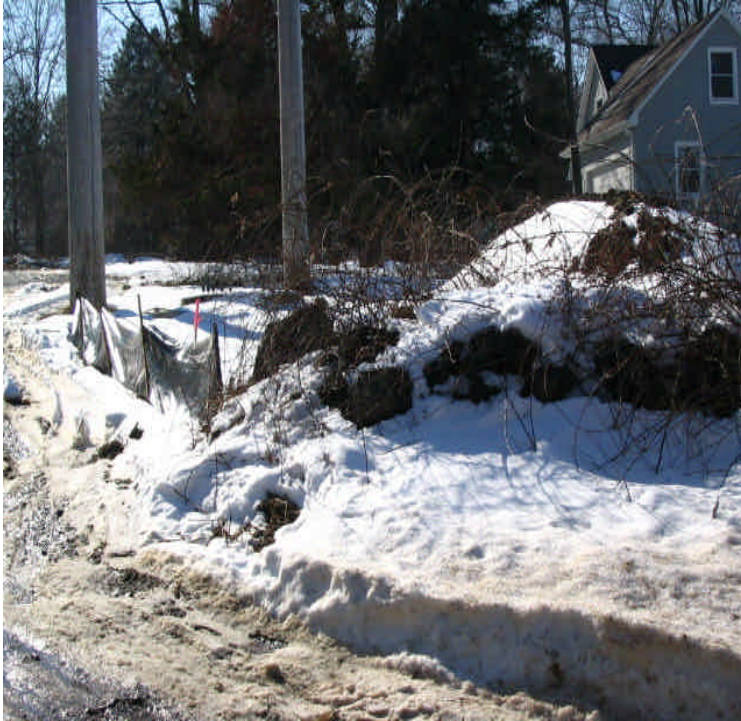
Photo on the left shows a view of the soil stockpile near pole #9 off Chestnut Ridge Rd. This pile should be removed as soon as feasible. Photo on the right shows a leak at a piece of equipment pads were placed but more were needed. It was being fixed at the time of inspection. 2/16/06

Bethel Reservoir Section to Chestnut Ridge Rd.	<p>- The stockpile from structure #9 foundation installation was still present. The silt fence here has a gap in coverage. 1/26-2/16/06</p> <p>- The matted crossing between proposed poles #10-11 had</p>	<p>- The stockpile should be removed as soon as feasible to prevent run-off to the road. 2/16/06</p> <p>- Install silt fence or haybales at the “four corners” of the mat. Consider stone or chips</p>

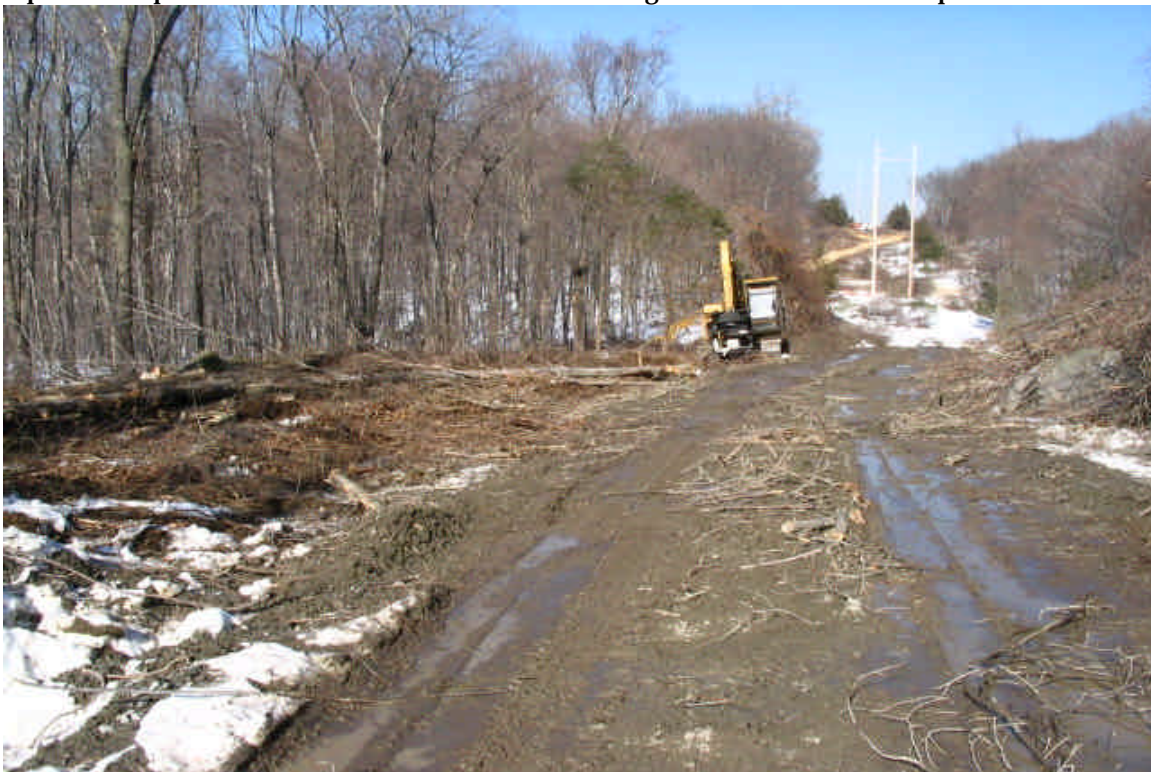
View of the clearing effort that is ongoing along the Chestnut Ridge Rd. to Hoyts Hill section. Attempt to preserve shrubs where possible and carefully remove downed brush and trees from the wetland. 2/16/06

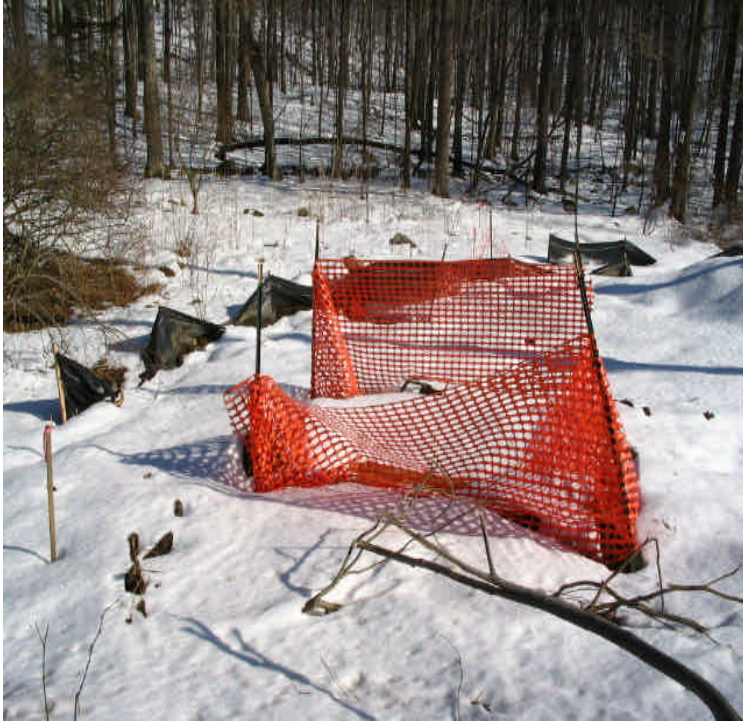
Photo on the left shows the excavation and silt fence near pole #6. snow may have impacted the silt fence. Check to see if it needs repairs and remove sediment when feasible. Photo on the right shows the clearing and chipping near pole #5. 2/16/06

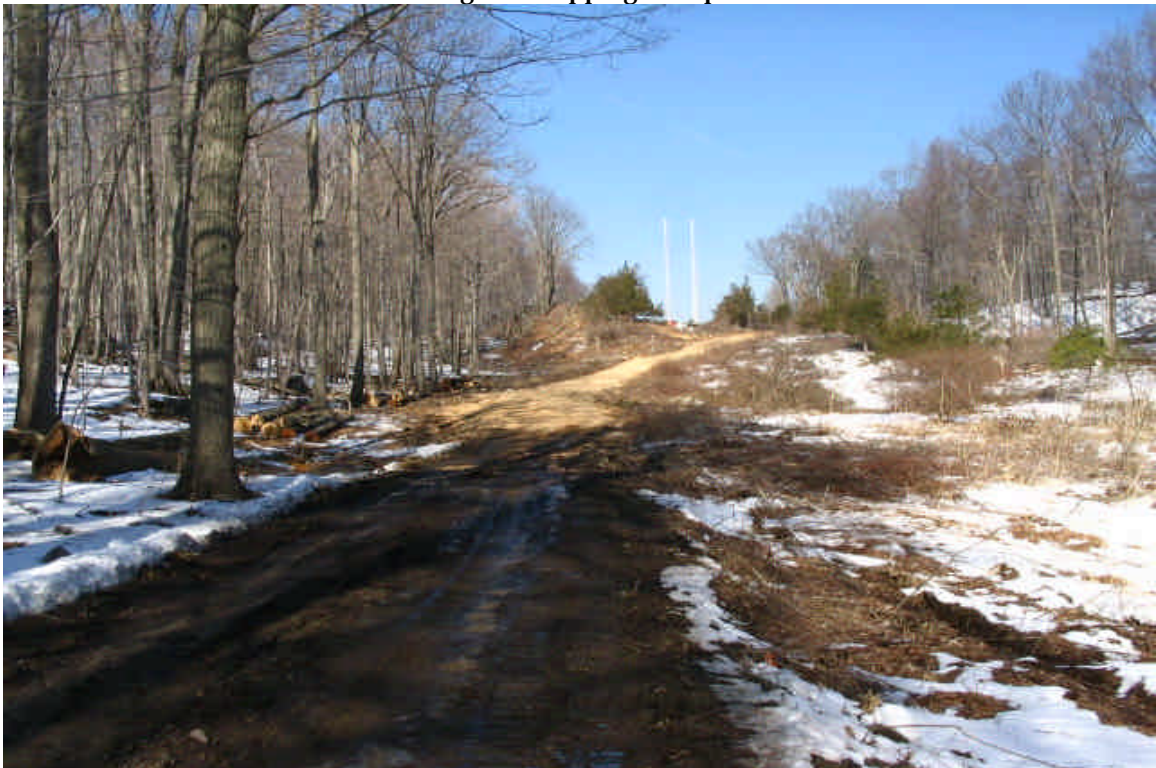
View along the ROW of the cleared area between poles #5 and 6. Wood chips were spread along part of the access road. If chips are not placed along the entire way, silt fence should be added along the road towards #6 to prevent sedimentation to adjacent wetlands. 2/16/06
